The first of the terms of reference set out in the Order in Council that established this Inquiry deals with the direct cause of death of the 26 miners on 9 May 1992.¹ This Inquiry must address two main questions: How did those 26 miners die? And why did those 26 miners die? The “how” is relatively straightforward and will be answered, as best it can be, in this chapter. The “why” is decidedly more difficult and involves multifaceted considerations – of planning, development, supervision, management, and regulations – that take the balance of this Report to address and, as possible, to resolve. In my capacity both as a special examiner under the *Coal Mines Regulation Act* and as a Commissioner under the *Public Inquiries Act*, I feel it is incumbent on me to “inquire into and report” on the proximate and probable cause of the explosion.

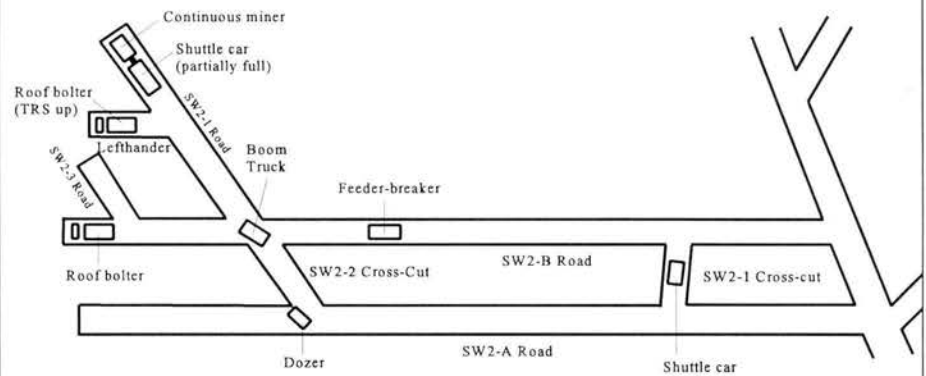
Figure 6.1 The Southwest 2 Section of the Mine, Showing Locations of Equipment at the Time of the Explosion

Continuous miner and shuttle car Don Dooley noted that the shuttle car showed very little evidence of burning. The driver’s seat was not burnt, nor were the tires.¹⁴ David Sample said the shuttle car was “parked behind the continuous miner in the position it would be to be loaded and was at least seven-eighths loaded with coal.”¹⁵ Wyman Gosbee confirmed the

Roof bolter in SW2-B Road This bolter was located at the face of SW2-B some 50 m from the intersection of SW2-2 Cross-cut and SW2-B Road. Jay Dooley described a piece of screening found at the top of SW2-B Road as being “at the bolter.”²² According to Facette, it was the bolter at the face of SW2-B Road on which he was working on 8 May along with Nelson LeDrew.²³

In their evidence, some witnesses considered the boom truck a possible source of ignition. It was located at the intersection of SW2-B Road and SW2-2 Cross-cut (the continuation of SW2-1 Road), 100 m from the working face where the continuous miner was found. As shown in photo 21, the boom truck is a low-slung vehicle, lying quite close to the road. According to Bossert, this truck (No. 975-0414) was built in 1975 and originally conformed to U.S. standards as a flameproof machine. It was first used by Kaiser Resources at its hydraulic coal mine in British Columbia. Over the years, the boom truck underwent substantial modifications, which appear to have affected its flameproof condition:

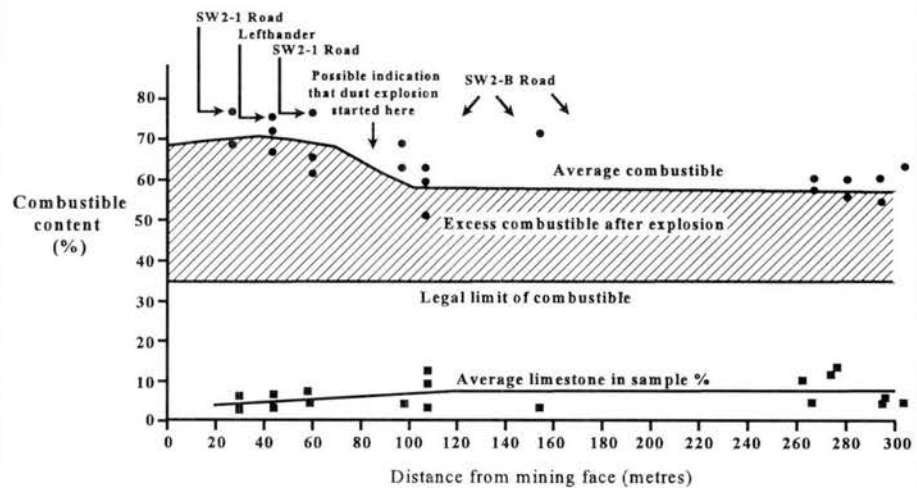
Figure 6.5 Analysis of Post-Explosion Dust Samples from the Southwest Section, Westray Mine

McPherson observed that there was considerable scatter of the points on the Richmond graph (figure 6.5). Because of such scatter, no "well-defined line" could be drawn through the points. He also suggested that, in moving away from the working face of a mine, one usually found a reduction in combustible content. He concluded: "This particular set of results shows that the combustible content was lower in the throughflow airways than in the headings. I would be hesitant to put any stronger interpretation than that upon them."⁸⁰

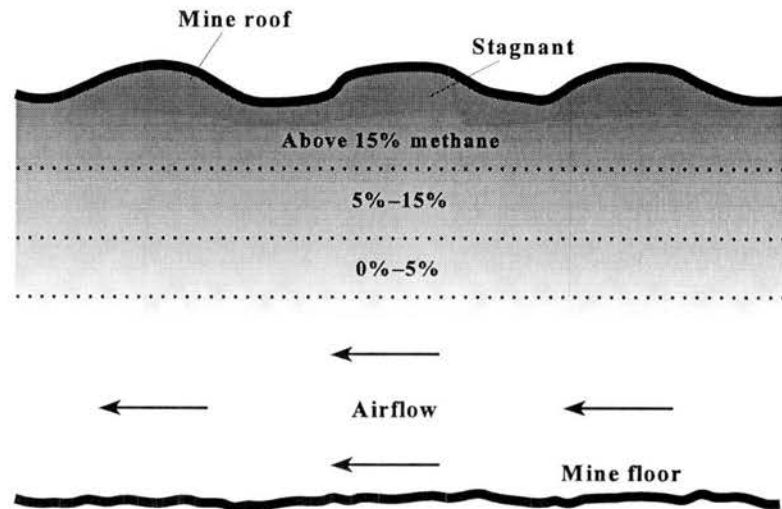
Figure 6.7 Methane Layering Near the Roof of a Coal Mine Opening

We may conclude that there was a considerable degree of methane layering in the Southwest section of the Westray mine at the time leading up to the 9 May explosion.⁸³ Because methane, like the helium we use in balloons, is lighter than air,⁸⁴ it will tend to rise to the roof of mine openings once it has been liberated by the mining process or by fissures in the coal seams. With proper ventilation, the methane will be diluted by mixing with the main body of air; once mixed, it cannot segregate out again to form layering.⁸⁵ Without adequate ventilation, the methane will tend to accumulate on the roof in methane-air mixtures that may vary from almost pure methane (up to 100 per cent) to non-combustible quantities of less than 5 per cent. As the term implies, layering may also refer to the percentage of methane at any particular level near the roof of an opening. Methane content will likely be highest at the roof. Depending on ventilation conditions and the thickness of the methane layer, methane content may decrease with distance down from the roof. At some point, it will pass through its explosive zone (5–15 per cent). Then, as it gets closer to the airflow, the methane layer will be reduced to non-flammable levels of less than 5 per cent. Where the mine roof is uneven, particularly where overbreaks or cavities are created by roof falls, the methane may become trapped in the resulting cavities and remain undisturbed by the ventilating air passing through the mine roadway. This scenario is illustrated in figure 6.7.
