The first of the terms of reference set out in the Order in Council that established this Inquiry deals with the direct cause of death of the 26 miners on 9 May 1992.¹ This Inquiry must address two main questions: How did those 26 miners die? And why did those 26 miners die? The “how” is relatively straightforward and will be answered, as best it can be, in this chapter. The “why” is decidedly more difficult and involves multifaceted considerations – of planning, development, supervision, management, and regulations – that take the balance of this Report to address and, as possible, to resolve. In my capacity both as a special examiner under the *Coal Mines Regulation Act* and as a Commissioner under the *Public Inquiries Act*, I feel it is incumbent on me to “inquire into and report” on the proximate and probable cause of the explosion.

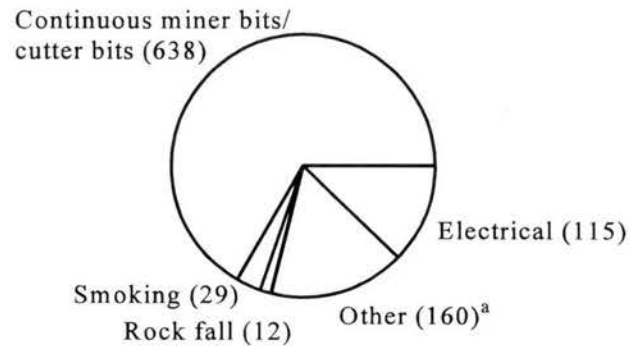
Figure 6.2 Number of Ignitions and Explosions by Cause (U.S. Coal Mines, 1959–81)

overwhelming cause of U.S. coal mine explosions from 1959 to 1981 was continuous miner bits. Figure 6.2 illustrates that, of the 954 recorded “incidents,” 638 were attributable to frictional ignition from continuous miner (and other cutter) bits. These findings were largely supported in a study by John Nagy for the U.S. Mine Safety and Health Administration (MSHA) in 1981. As a result of his analysis, Nagy concluded:

Eighty-five percent of these ignitions were caused by frictional sparks generated by cutting machines or continuous mining machines when the bits struck hard materials at the working face. Each ignition has the potential to become an explosion if sufficient force develops to cause damage. . . . The trend in methane ignitions in British coal mines is approximately the same as in American coal mines.⁶⁶

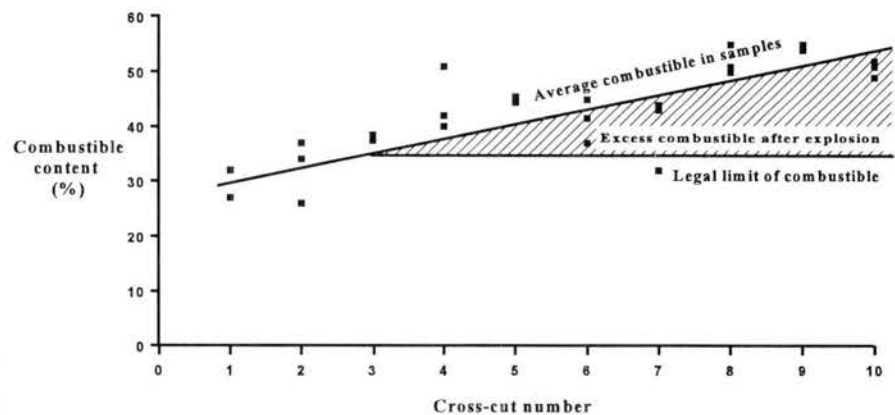
Figure 6.6 Analysis of Post-Explosion Dust Samples from Cross-cuts between No. 1 and No. 2 Mains, Westray Mine

McPherson also presented a graph (figure 6.6), showing the results of dust sample tests from the cross-cuts of the main roadways – No. 1 Main (intake) and No. 2 Main (return). He explained the straight, ascending line this way: "This plot indicates that the further we move down the mains into the mine, the greater is the amount of coal in the settled dust. This is hardly a surprising result and is a trend that we could find in the majority of drift (slope) coal mines." In his concluding remarks, McPherson made the following comment:
